## **COPYTHORNE PARISH COUNCIL MEETING - TUESDAY 13<sup>TH</sup> OCTOBER 2020**

### **ITEM NO: 11 – Playground Inspection – Operational Inspection Report / Summary of members Visual Inspections**

**N. W. Adams**  
Engineering Design Services

4th August 2020

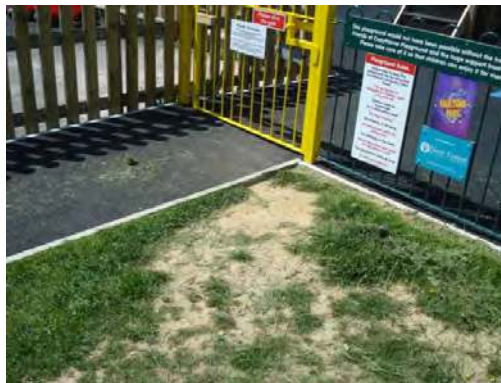
photo 1

Soil erosion abutting the PCC edging creating a trip hazard (this is partially due to wheel & push chair users having to step aside the gate arc to gain access). *Make up flush with topsoil & re-grass in the appropriate season, if erosion & puddles remain a problem, consider slabs, grass reinforcement mats laid on mesh/geotextile material on an even surface, chased into the soil at the edges to avoid sharp gradients (<1:5) & trip zones is suggested or other durable surface (photo 1).* Medium risk

1. Access Pathway – Soil Erosion creating a Trip Hazard *Issue was initially resolved by the use of undersoil strengthening and ground levelling. However, some further erosion is noted, but it is believed that the new bicycle racks when installed will help 'deflect' the traffic and relieve the pressure on a strip of ground by the gate*

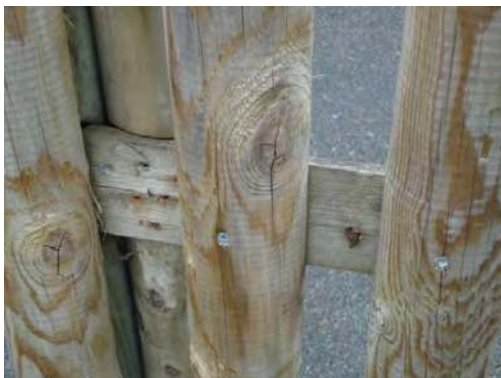
photo 2

Several sharp nail points projecting from the original timber fence rail abutting the play area.  
*File/knock down flush to timber (photo 2).*

4. Fencing - sharp nails projecting from original timber fence – *Nails were removed but the Inspector has managed to find a new one which needs to be dealt with!*

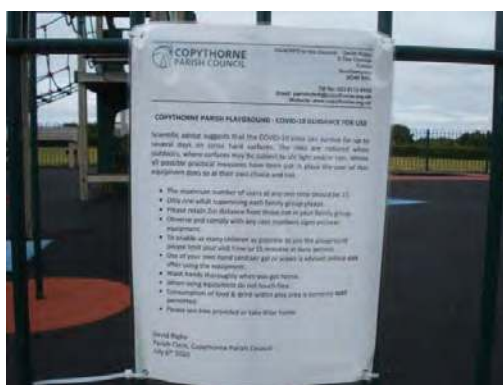
photo 3

(i) attached to fence complete with contact details (4) (photo 3).

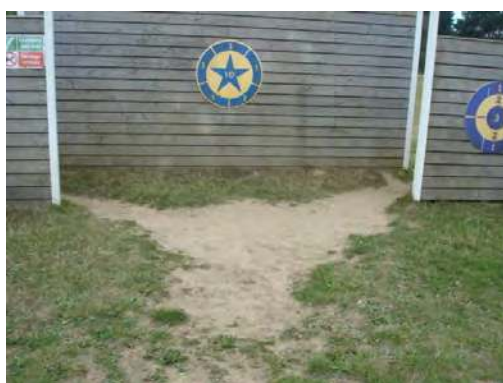
photo 4

# Pedestrian traffic worn route through to the field behind the MUGA. *Monitor for sports balls conflicting with persons using the through route/consider providing a completely separate access (photo 4).*

# *Make up playing surface level & flush with topsoil & re-grass in the appropriate season, if erosion & puddles remain a problem, programming for the provision of a durable artificial surface recommended for consideration (photo 4).*
