## COPYTHORNE PARISH COUNCIL MEETING – MARCH 8TH 2022

### ITEM NO: 10 – Playground Inspection – Operational Maintenance Inspection Report / Summary of weekly Visual Inspections

Operational Maintenance Inspection Report of the Play & Sports  
facilities at Pollards Moor Road, Copythorne

1st February 2022

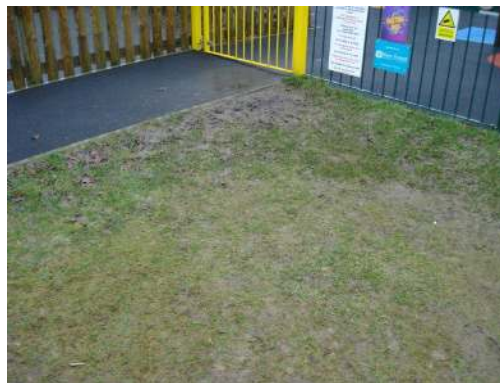
photo 1

Soil erosion abutting the PCC edging creating a trip hazard (this is partially due to wheel & push chair user having to step aside the gate arc to gain access).

Make up flush with topsoil & re-grass in the appropriate season, if erosion & puddles remain a problem, the provision of slabs or a durable surface similar to play equipment grass mats laid on mesh/geotextile material on an even surface, chased into the soil at the edges to avoid sharp gradients (<1:5) & trip zones is suggested (photo 1). Medium risk

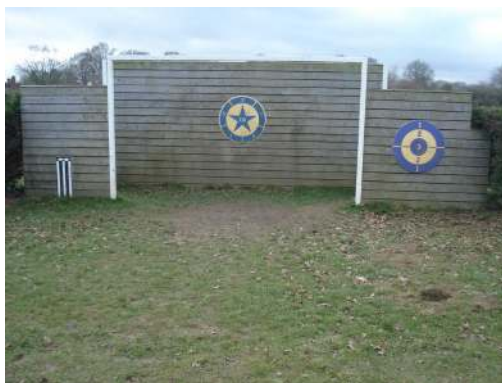
photo 2 (N.E. play area side)

An alternative route (separate access) has been provided to deter the route through the ball screen side gaps, however, for stray ball retrieval, this is unlikely to be used.

*Maintain the playing surface level & flush with topsoil & re-grassing in the appropriate season. If erosion, ruts & puddles remain a problem, programme for the provision of a durable artificial surface is recommended for consideration (photo 2).*

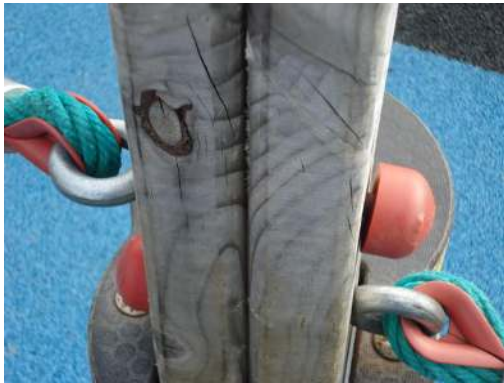
photo 3 (lower)

Loose central post upper and lower cable end eye bolts. *Remove cover caps, tighten & replace caps (photos 3 & 4).*
