## COPYTHORNE PARISH COUNCIL MEETING – DECEMBER 13<sup>TH</sup> 2022

### ITEM NO: 10 – Playground Inspection – Operational Maintenance Inspection Report / Summary of members Visual Inspections

Annual Inspection Report of the Play & Sports facilities at  
Pollards Moor Road, Copythorne

31st August 2022

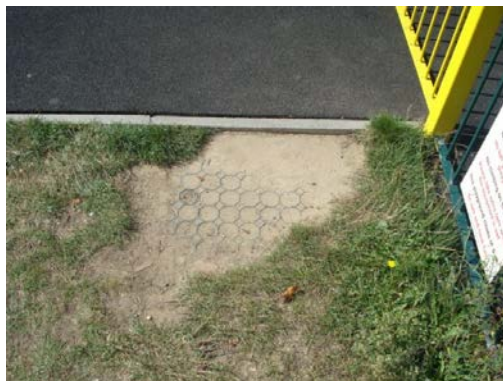
photo 1

Matrix grass reinforcement settlement abutting the PCC edging creating a trip hazard (this is partially due to wheel & push chair users having to step aside the gate arc to gain access).  
*Adjust surface up flush to the edging to eliminate the trip zone (photo 1). Medium risk*

2. Access Pathway – *Matrix grass reinforcement settlement abutting the PCC edging creating a trip hazard. Adjust surface up flush to the edging to eliminate the trip zone* **Suggested action to be undertaken by a “working party”**
