## COPYTHORNE PARISH COUNCIL MEETING – OCTOBER 8<sup>TH</sup> 2024

### ITEM NO: 9 – Playground Inspection – Annual Inspection Report

Annual Inspection Report of the Play & Sports facilities at  
Pollards Moor Road, Copythorne

13th September 2024

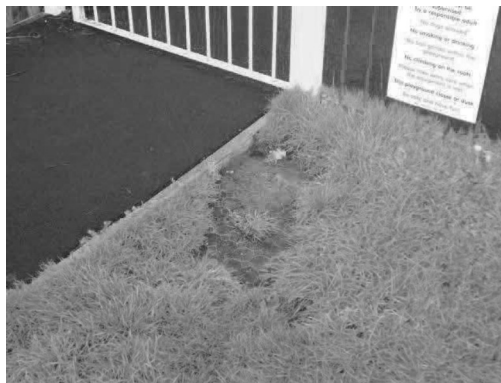
photo 1

Matrix grass reinforcement settlement abutting the PCC edging creating a trip hazard (this is partially due to wheel & push chair users having to step aside the gate arc to gain access).  
*Adjust surface up flush to the edging to eliminate the trip zone (photo 1).* Medium risk

2. Access Pathway – Matrix grass reinforcement settlement abutting the PCC edging creating a trip hazard. *Adjust surface up flush to the edging to eliminate the trip zone* **Suggested action to be undertaken by a “working party”.**

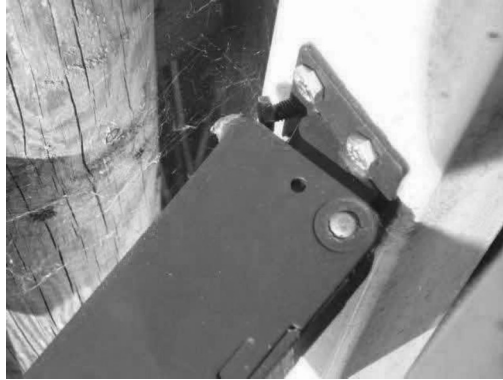
photo 2

Crush point between the attached gate modification closure mechanism & the fence.  
*Adjust the stop screw (bent) to provide a 12mm minimum gap (photo 2). Low/medium risk*

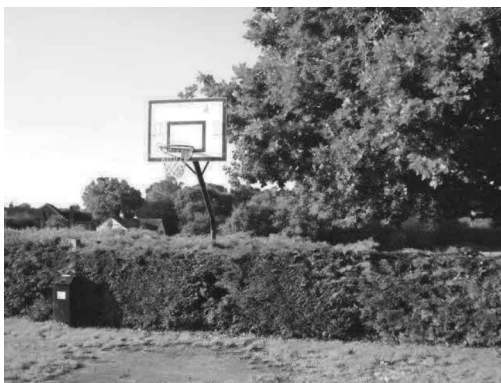
photo 3

Oak tree encroachment around the basketball post playing area. *Trim back to 2.0m minimum from the back board & at least 2.5m from the ground maintaining as such (photo 3).*

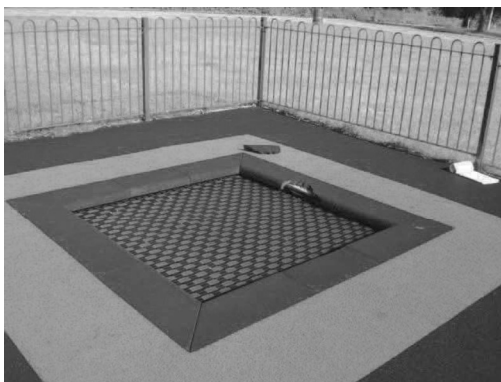
photo 5

Damaged/removed section of black rubber edging tile. *Replace and re-glue to the supporting surface beneath securely (this was partially achieved to mask the exposed metal frame during the inspection and a replacement tile has been ordered to replace the damaged tile as soon as possible)/monitor for further loosened tiles (photo 5).* Low/medium risk

13. Trampoline – Minor Litter visible beneath the rebound surface - *Programme to remove, contact supplier regarding advice on access for cleansing.* **“No risk issue”**  
 Trampoline – Damaged/removed section of black rubber edging tile. *Replace and re-glue to the supporting surface beneath.* **Work to be undertaken by playground contractor, date awaited.**

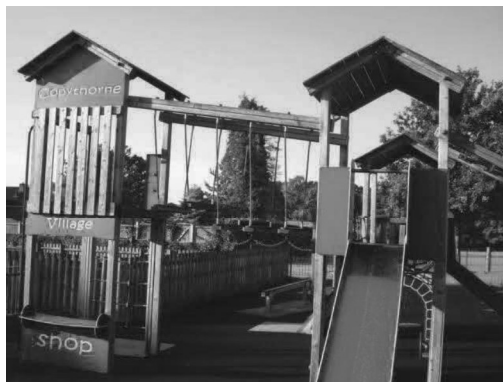
photo 6

*Open suspended bridge. Some parts of this multi-play unit are 'easily accessible' (via the stairs). There have been recorded falling injuries from such structures when young children have gained access or have been inadvertently placed on parts of equipment which is unsuitable/not designed for their age group (see 'Signs' above). Consider an additional platform beneath the suspended bridge boards particularly/refer to the Supplier (photo 6).*
