# COPYTHORNE PARISH COUNCIL MEETING – OCTOBER 14<sup>TH</sup> 2025

## ITEM NO: 9 – Playground Inspection – Annual Inspection Report

Annual Inspection Report of the Play & Sports facilities at  
Pollards Moor Road, Copythorne

19th September 2025

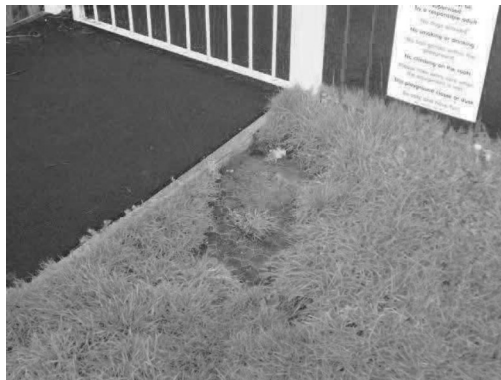
photo 1

2. Access Pathway – Matrix grass reinforcement settlement abutting the PCC edging creating a trip hazard. *Adjust durable surface flush to the edging to eliminate the trip zone* **Suggested action to be undertaken by a “working party”.**

Matrix grass reinforcement settlement abutting the PCC edging creating a trip hazard (this is partially due to wheel & push chair users having to step aside the gate arc to gain access). *Adjust durable surface flush to the edging to eliminate the trip zone (photo 1).* Medium risk

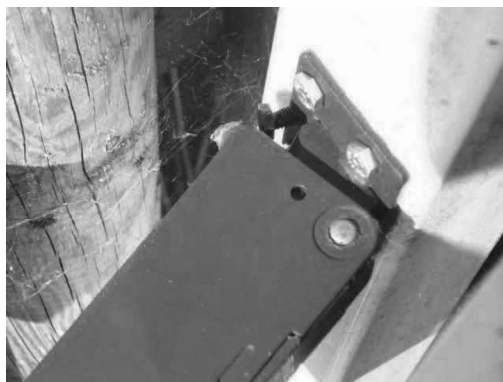
photo 2

Crush point between the attached gate modification closure mechanism & the timber fence. *The stop screw is bent & ineffective, recommend fitting a stop post/rubber buffer to provide a 12mm minimum gap (photo 2).* Low/medium risk

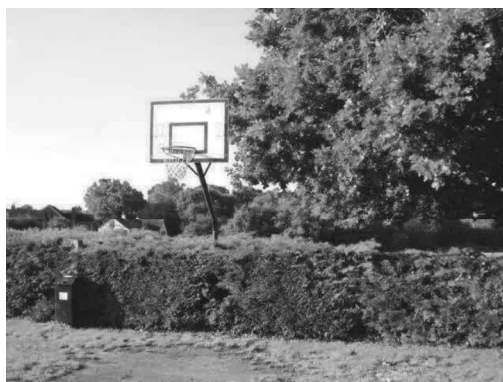
photo 3

Oak tree encroachment around the basketball post playing area. *Trim back to 2.0m minimum from the back board & at least 2.5m from the ground maintaining as such (photo 3).*

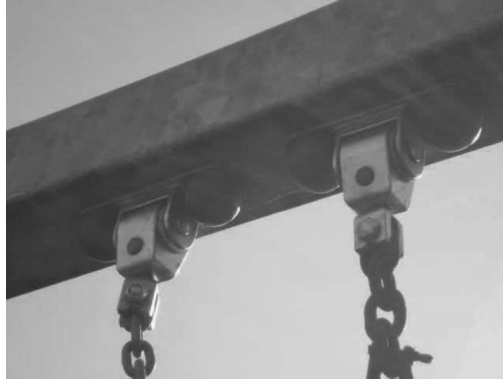
photo 4

*Recommend annual lubrication of the swing swivel pins (4) internally by removing the black plastic cap particularly for the main chain seat supports (photo 4).*

*Recommend annual lubrication of the swing swivel pins (4) internally by removing the black plastic cap for the main chain seat supports (see photo 4).*

*Recommend annual lubrication of the swing swivel pins.* **Annual task to be undertaken by playground contractor**

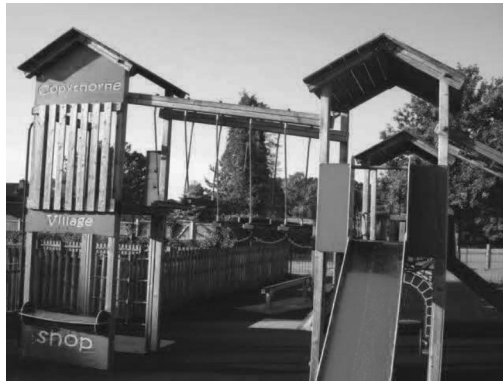
photo 5

Open suspended bridge. *Some parts of this multi-play unit are 'easily accessible' (via the stairs). There have been recorded falling injuries from such structures when young children have gained access or have been inadvertently placed on parts of equipment which is unsuitable/not designed for their age group (see 'Signs' above). Consider an additional platform beneath the suspended bridge boards particularly/refer to the Supplier (photo 5).*

Multi-unit – Open Suspension bridge *Consider an additional platform beneath if a problem particularly for younger users/monitor.* **This has not been raised as an issue by users/parents, ongoing monitor.**
