**COPYTHORNE PARISH COUNCIL MEETING – 9<sup>th</sup> MARCH 2021**  
**ITEM 18 – COUNCILLORS' REPORTS – JOHN GOODWIN**

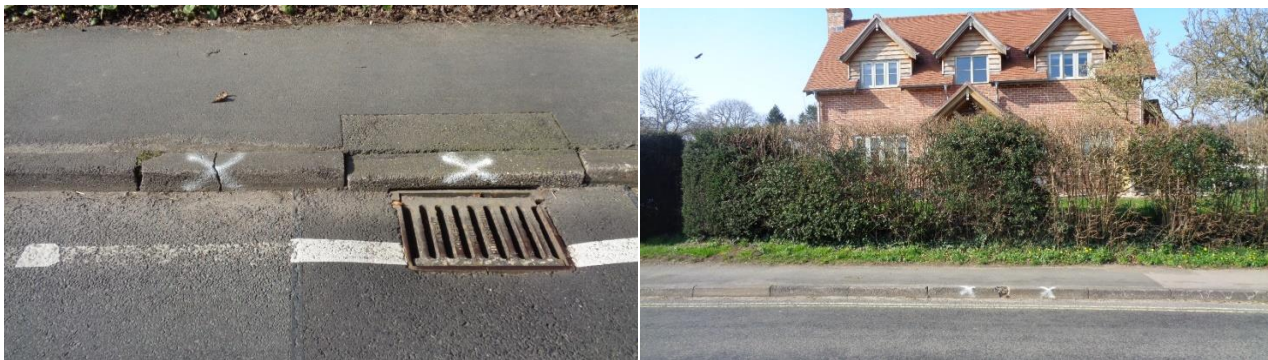
**2. Gully outside The Wilderness, Winsor Road, WINSOR:**

As an update from last month I can report that white markings have now appeared on the adjacent kerbing and also on kerbs outside Gardenia. Updates will continue to be issued.

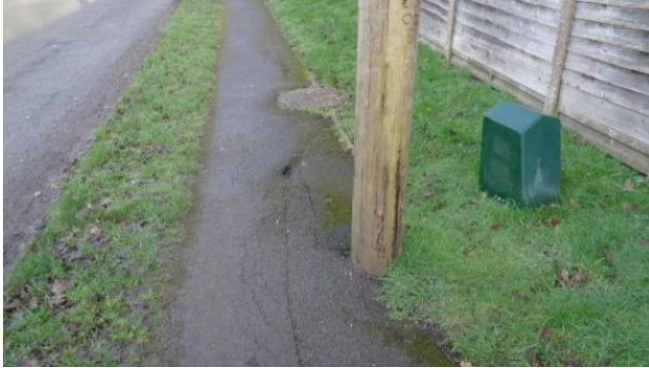
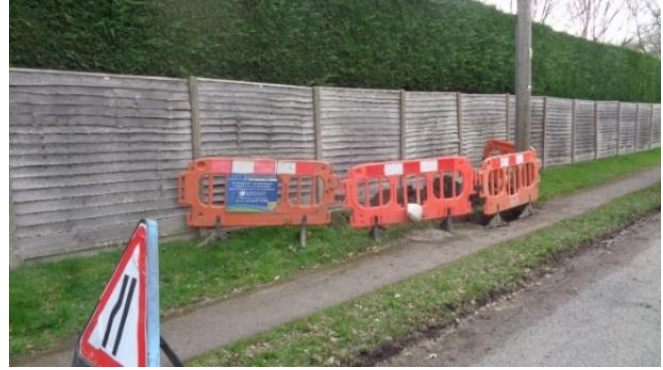
**i) Electricity Transmission Pole through Highway Drain**

Following investigative work carried out by Scottish and Southern Electricity on Wednesday 24<sup>th</sup> February 2021, it has now been established that the pole was, when installed some 25 years ago, on the line of the existing 300mm highway drain. However, the excavation made has revealed that since this time sections of the damaged highway drain have been removed and the remaining ends of the highway drain sealed. This means that the highway drain cannot function, under any circumstance, and this could be the primary contributing factor to the downstream waterlogged condition of the footpath and area between Vicarage Lane and by Southern Water's pumping station. The sealing of this surface water drainage route may also be the major contributor to the surface water flooding incidents in Pollards Moor Road, which has led to the internal flooding on a number of occasions of a property further north in Pollards Moor Road.

Notes of site visits and meetings held with Hampshire County Council representatives in 2014, following the last major flooding incident in this area, show that HCC were aware of the pole obstructing the highway drain and had agreed to carry out the necessary work to reinstate the drain at this and other (pole) location where it was assumed a similar situation existed.

At a subsequent meeting today, Monday 1<sup>st</sup> March 2021, with Tom, the site foreman from SSE's sub-contractors Holmes of Southampton, he was to report back that the reinstatement work

required was a little more involved than originally envisaged. It is believed that a similar situation will be found at other pole locations along Pollards Moor Road. Further updates will be reported.

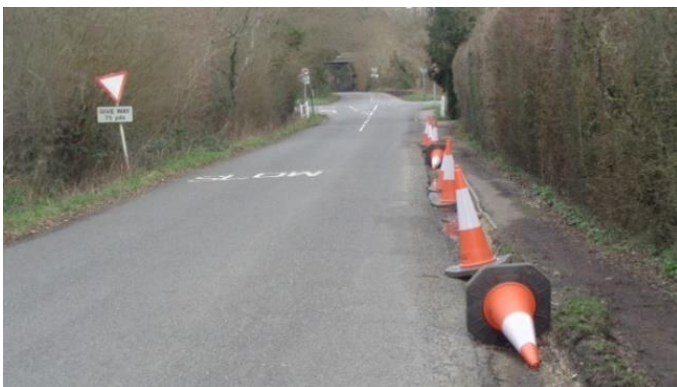
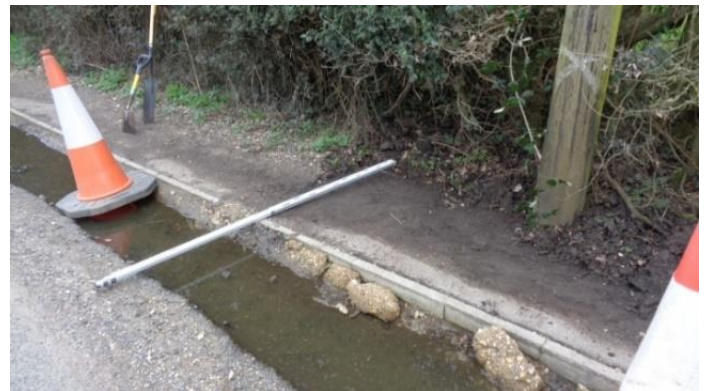
## ii) Footpath/Road condition adjacent to Southern Water's Pumping Station

It was Christmas last year when Southern Water started tankering operations at this pumping station, following it being taken out of action to relieve the load on a pumping station further down the line where major works were being carried out. This work ceased in mid-January and as at the date this report was submitted, Monday 1<sup>st</sup> March 2021, there has still not been any action to reinstate the footpath, kerbing etc.

With schools scheduled to reopen on Monday 8<sup>th</sup> March 2021 this footpath, being only on one side of the road, will once again become one of the most well used footpaths in the Parish. A recently cleared section has confirmed that the full width of the footpath is 1.2m (4ft) and this is the width that should be cleared along the full length. With the information that has been found in the report above, HCC should really treat this reinstatement work with more urgency.

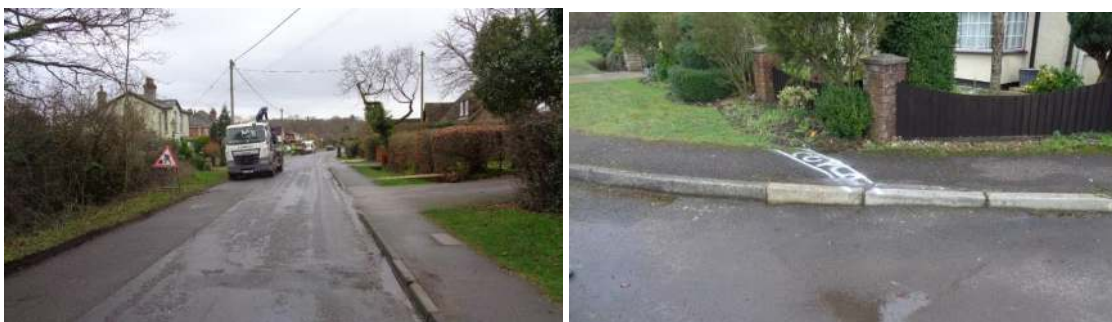
## 4. Blocked drain outside Oakfield House, New Inn Road, BARTLEY:

The blocked drain in New Inn Road outside Oakfield House, on the corner of Oakfield Road, was included in last month's report. It was hoped that a planned visit by HCC contractors would resolve the situation. However, this visit once again confirmed that there is a broken pipe under the adjacent footway at the top of Oakfield Road. HCC's contractor was able to partially clear the blockage so at least some of the time the ditch now can slowly drain away. The location of the blockage has been clearly marked to assist the next contractors visiting the site.

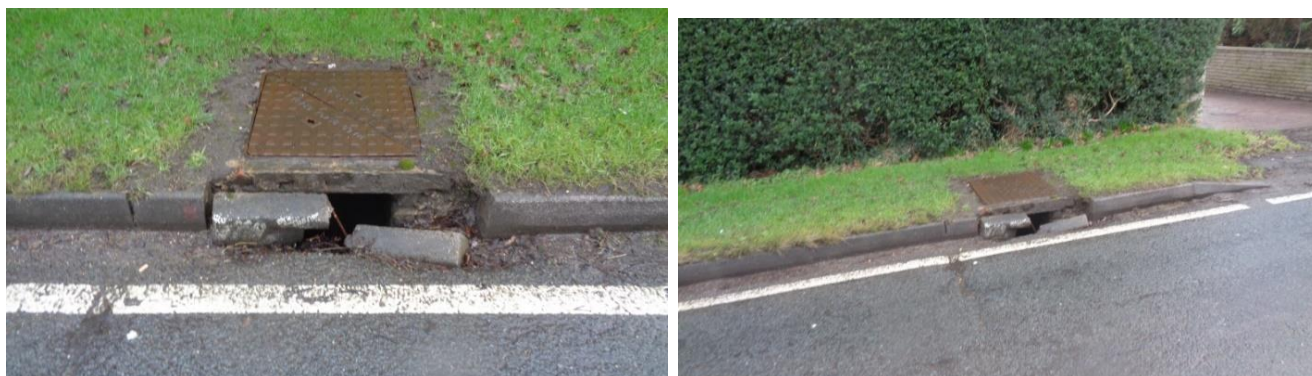
#### **5. Damaged gully, outside Augustine, Southampton Road, CADNAM:**

This damaged kerb gully (Ref: 21522789), outside Augustine, Southampton Road was reported on 18<sup>th</sup> October 2020, passed to contractor on 30<sup>th</sup> October 2020, programmed for repair on 22<sup>nd</sup> to 24<sup>th</sup> February 2021, yet still remains unrepaired as at the date of this report, Monday 1<sup>st</sup> March 2021.

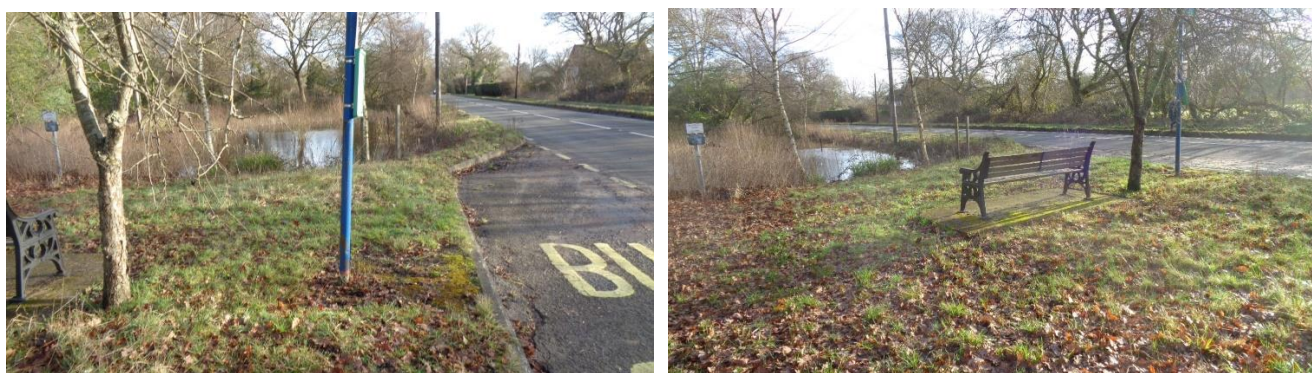
#### **6. Litter Bin at Splitwind Pond, Southampton Road, CADNAM:**

It has been brought to my attention by a local resident that the litter bin at Splitwind pond is missing. It was previously located alongside the bus stop layby as shown below.

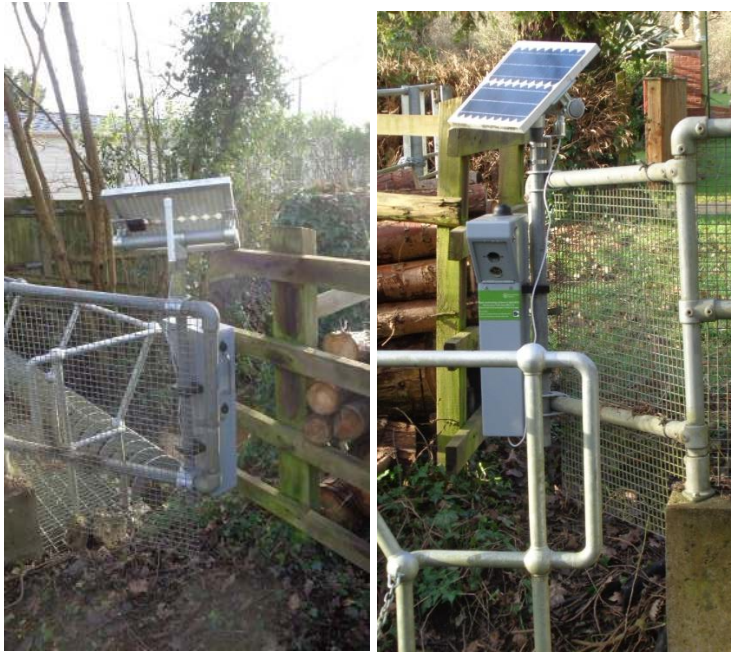
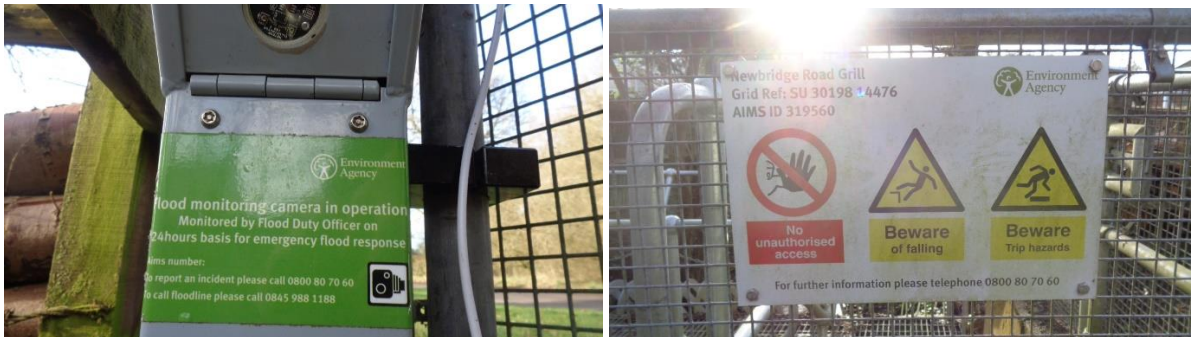
## 7. Telemetry adjacent to Riverside, Newbridge Road, CADNAM:

It has been noticed that a new camera-based telemetry system has been installed to monitor the trash screen on the Main River adjacent to Riverside at Newbridge Road.

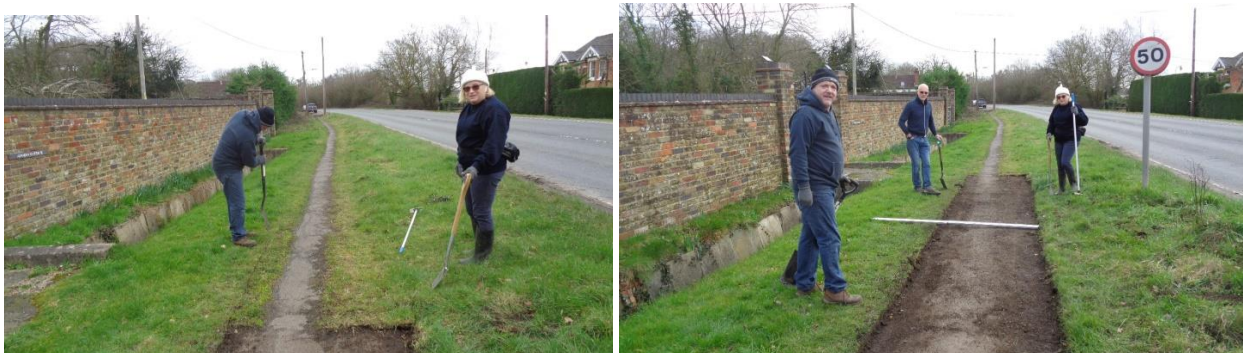
Well done to Dave and Eve Warren of Winsor Road, with help from another local resident, for their work in clearing the footpath near the layby in Southampton Road which had become badly overgrown.

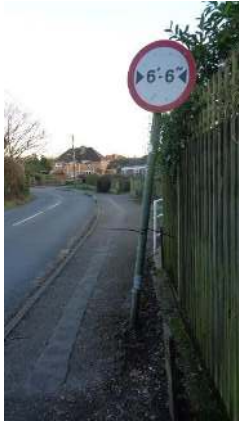
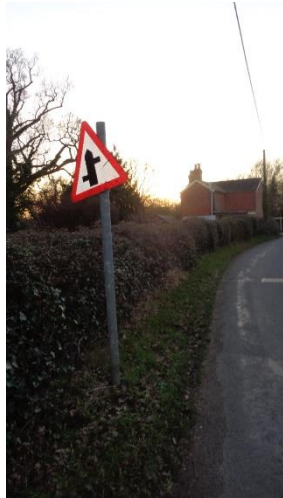
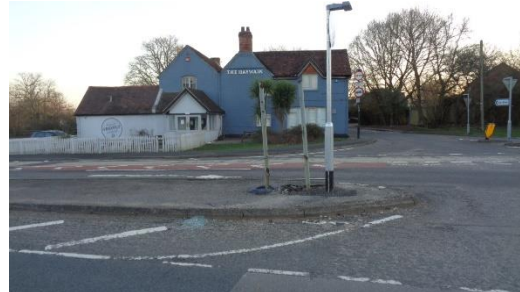
## 9. Road signs, various, BARTLEY:

The following local road signs in the village of Bartley need repair/attention:

- i) at the Chinham Road/Shepherds Road Junction;
- ii) Chinham Road approaching the Post Office and
- iii) Southampton Road by the Haywain.

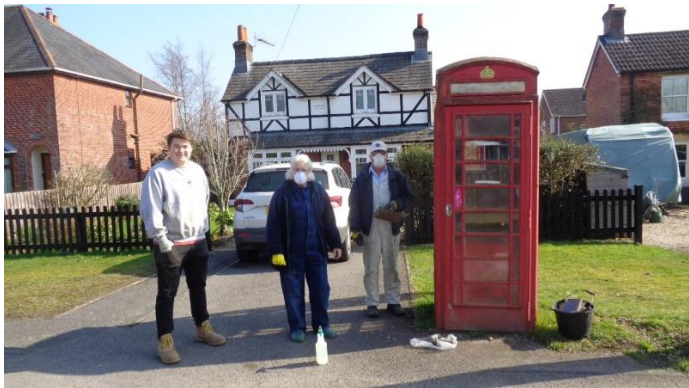
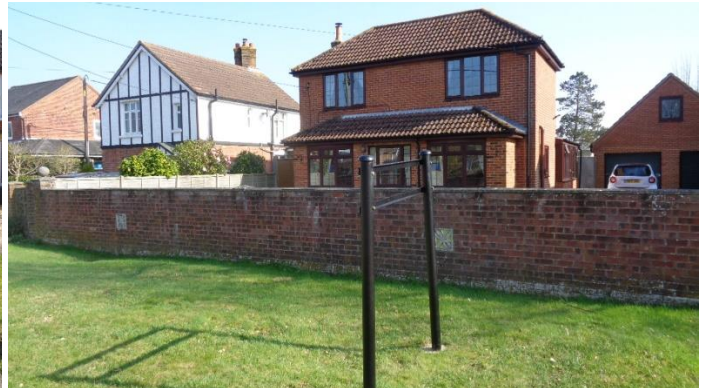
## 10. New Inn Road, BARTLEY – Telephone Box and sign:

Councillors Sylvia Wiggins and Graham Chillcott have been taking advantage of the fine weather by starting work on the refurbishment of the Telephone Box and getting the post and rails ready to welcome back the refurbished Bartley sign. Photographs taken in the sun on Monday 1<sup>st</sup> March 2021.
