Land off New Inn Road, Bartley SO40 2NA

## Addendum to Drainage Report

## Appendix A: Drainage survey report

**Project****Project Name:** New Inn Road\_ Bartley**Project Description:** CCTV Survey, Trace & Plot**Project Status:** Complete**Project Date:** 19/05/2023**Inspection Standard:** MSCC5 Sewers & Drainage GB (SRM5 Scoring)

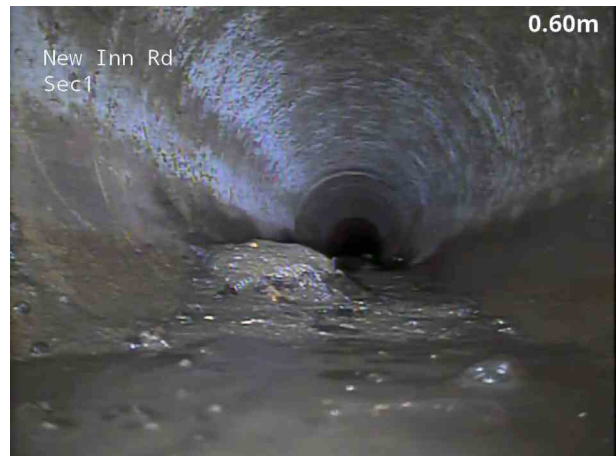
2, 00:00:08, 0.80 m  
Settled deposits, fine, 10% cross-sectional area loss, start

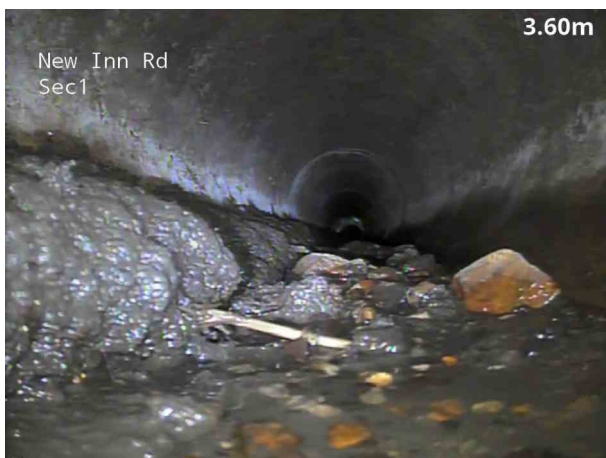
3, 00:00:25, 3.60 m  
Settled deposits, coarse, 10% cross-sectional area loss, start

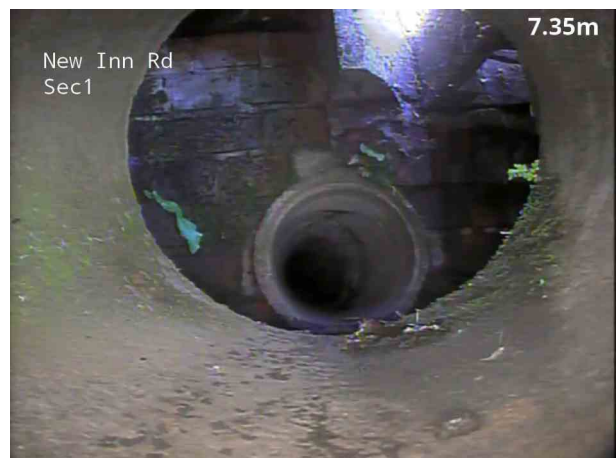
| Section | PLR | Grade | Description |
|---|---|---|---|
| 1 | CP3X | 3 | Multiple defects |

4, 00:00:48, 7.30 m  
Settled deposits, coarse, 10% cross-sectional area loss, finish

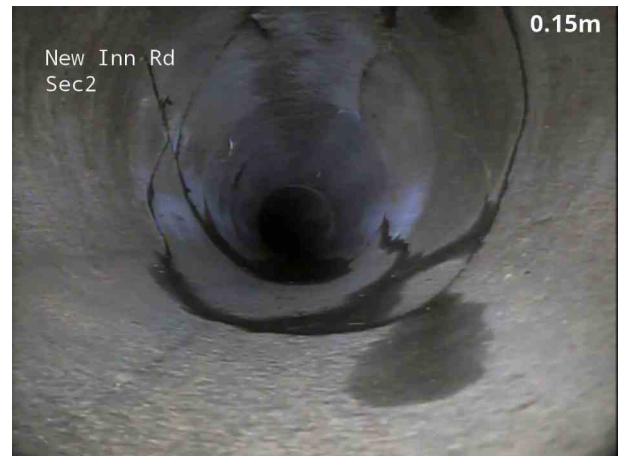
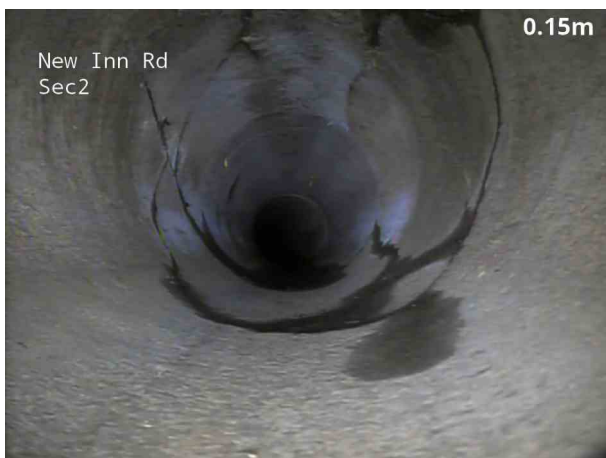
2, 00:00:05, 0.50 m  
Fractures, multiple from 12 o'clock to 12 o'clock, start

3, 00:00:05, 0.50 m  
Fractures, multiple from 12 o'clock to 12 o'clock, start

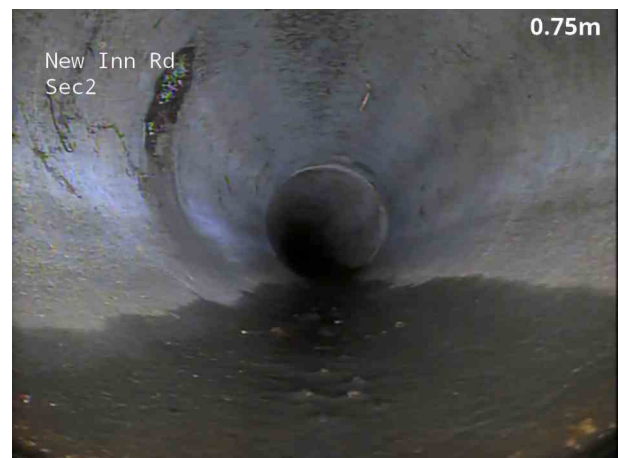
4, 00:00:09, 0.90 m  
Fractures, multiple from 12 o'clock to 12 o'clock, finish

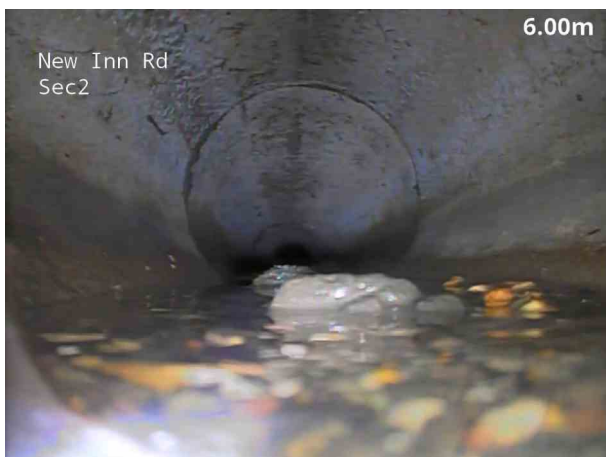
5, 00:00:23, 5.00 m  
Settled deposits, coarse, 10% cross-sectional area loss, start

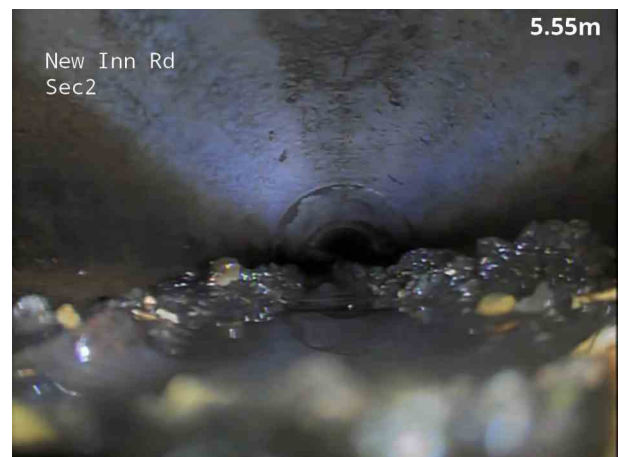
6, 00:00:26, 5.60 m  
Settled deposits, coarse, 20% cross-sectional area loss, change

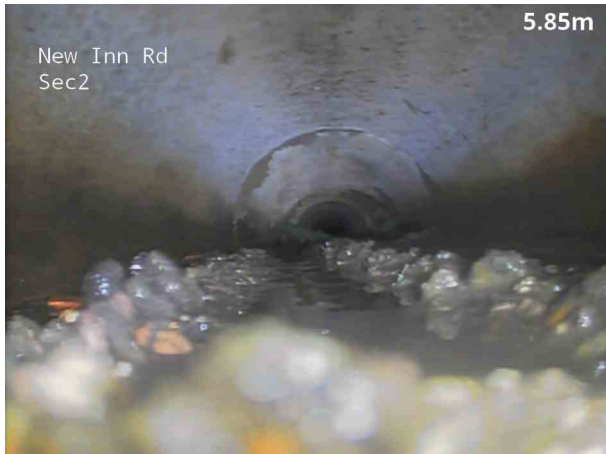
7, 00:00:29, 6.00 m  
Settled deposits, coarse, 30% cross-sectional area loss, change

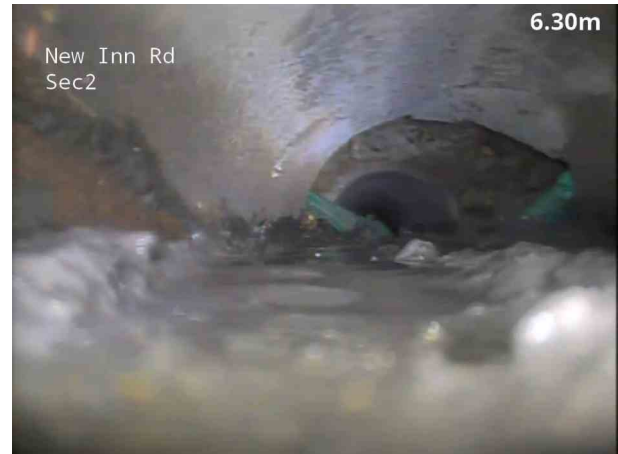
8, 00:01:12, 6.40 m  
Settled deposits, coarse, 40% cross-sectional area loss, change

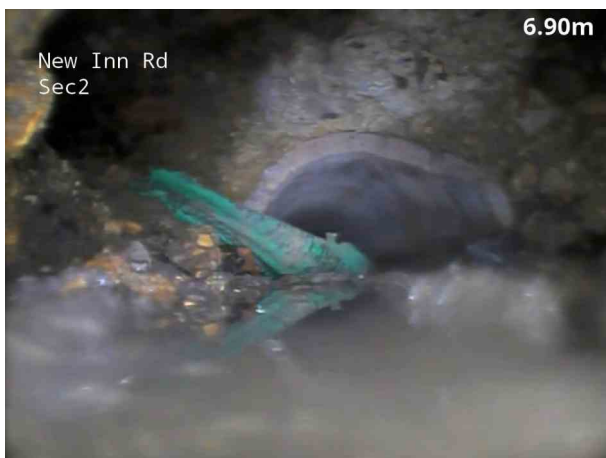
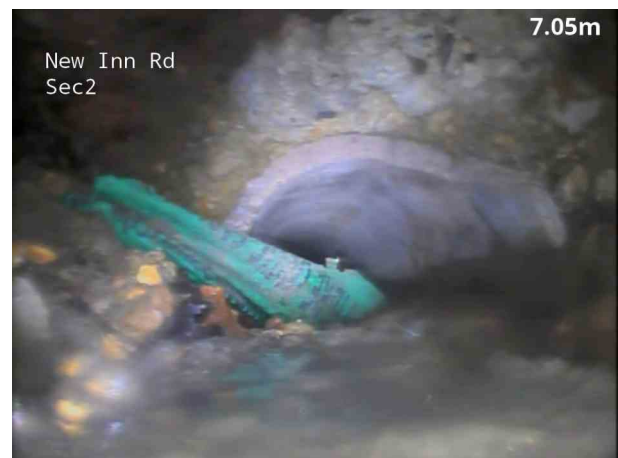
Grade 5: Best practice suggests that this pipe is at risk of collapse at any time. Urgent consideration should be given to repairs to avoid total failure.

| Section | PLR | Grade | Description |
|---|---|---|---|
| 2 | CP2X | 5 | Hole in drain or sewer from 8 o'clock to 4 o'clock, finish |

9, 00:01:22, 7.00 m  
Hole in drain or sewer from 8 o'clock to 4 o'clock, start

10, 00:01:22, 7.00 m  
Hole in drain or sewer from 8 o'clock to 4 o'clock, start

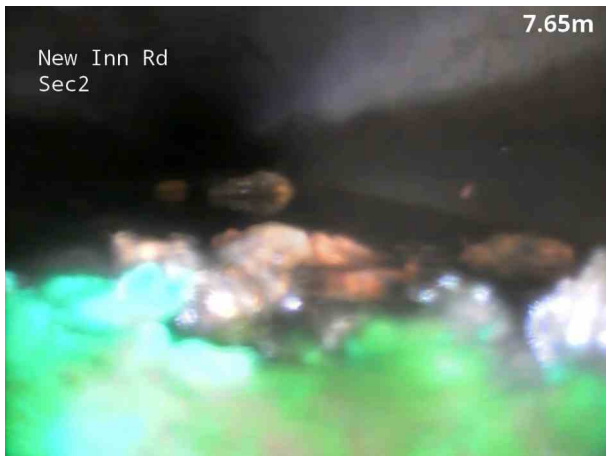
New Inn Rd  
Sec2

13, 00:01:45, 7.70 m  
Hole in drain or sewer from 8 o'clock to 4 o'clock, finish

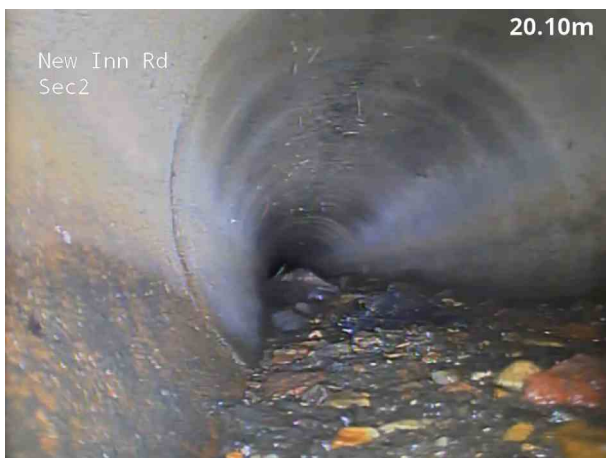
New Inn Rd  
Sec2

15, 00:02:37, 20.50 m  
Settled deposits, coarse, 20% cross-sectional area loss, change

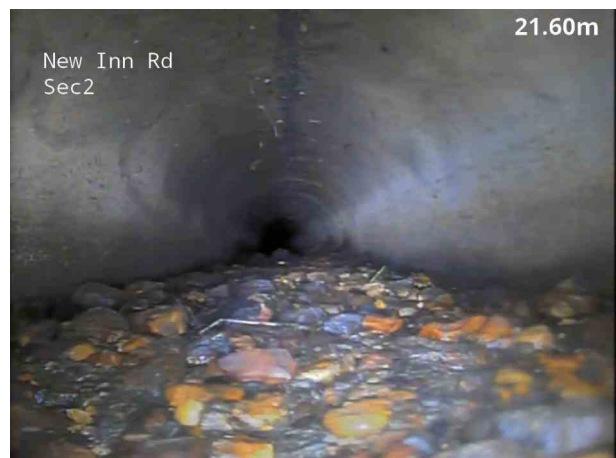
New Inn Rd  
Sec2

16, 00:02:43, 21.60 m  
Settled deposits, coarse, 25% cross-sectional area loss, change

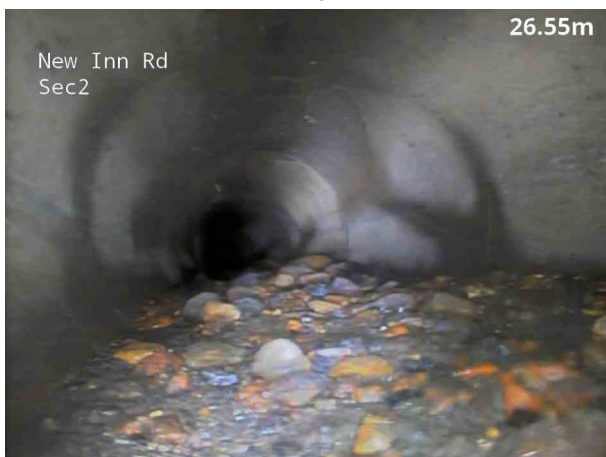
New Inn Rd  
Sec2

| Scale: 1:211 | Position [m] | Code | Observation | MPEG | Photo | Grade | |
|---|---|---|---|---|---|---|---|
| | 27.00 | FM | Fractures, multiple from 8 o'clock to 3 o'clock | 00:03:06 | 17 | 4 / 2 | |

17, 00:03:06, 27.00 m  
Fractures, multiple from 8 o'clock to 3 o'clock

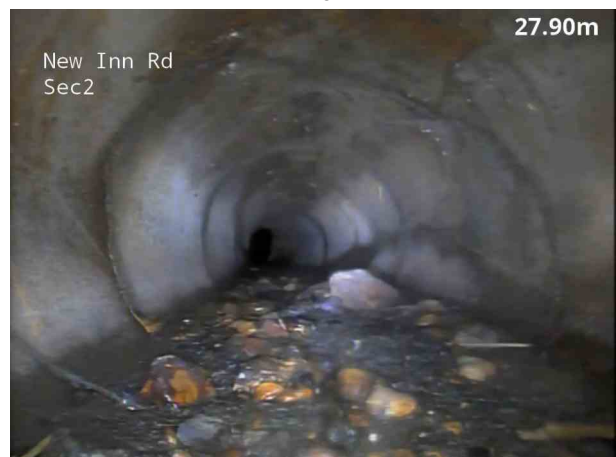
New Inn Rd  
Sec2

| Scale: 1:211 | Position [m] | Code | Observation | MPEG | Photo | Grade | |
|---|---|---|---|---|---|---|---|
| | 28.20 | S04 | FM | Fractures, multiple from 8 o'clock to 4 o'clock, start | 00:03:13 | 18 | |

18, 00:03:13, 28.20 m  
Fractures, multiple from 8 o'clock to 4 o'clock, start

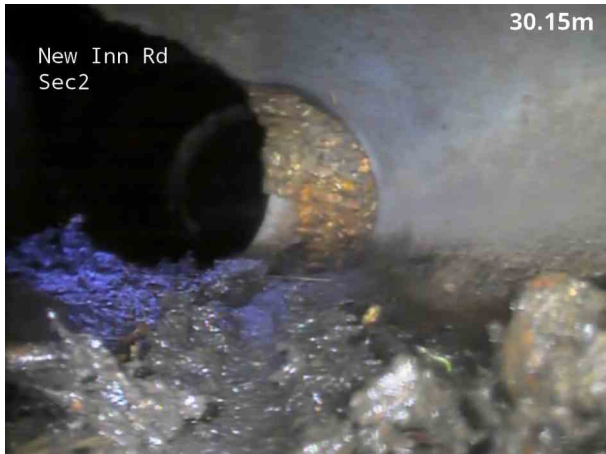
| Scale: 1:211 | Position [m] | Code | Observation | MPEG | Photo | Grade | |
|---|---|---|---|---|---|---|---|
| | 30.40 | B | | Broken pipe from 12 o'clock to 4 o'clock | 00:03:34 | 19 | 4 |

19, 00:03:34, 30.40 m  
Broken pipe from 12 o'clock to 4 o'clock

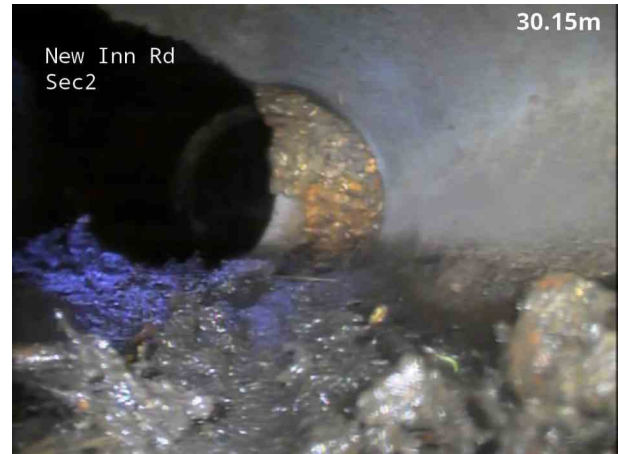
| Scale: 1:211 | Position [m] | Code | Observation | MPEG | Photo | Grade | |
|---|---|---|---|---|---|---|---|
| | 30.40 | LR | | Line deviates right: Junction with unknown | 00:03:35 | 20 | |

20, 00:03:35, 30.40 m  
Line deviates right, Junction with unknown

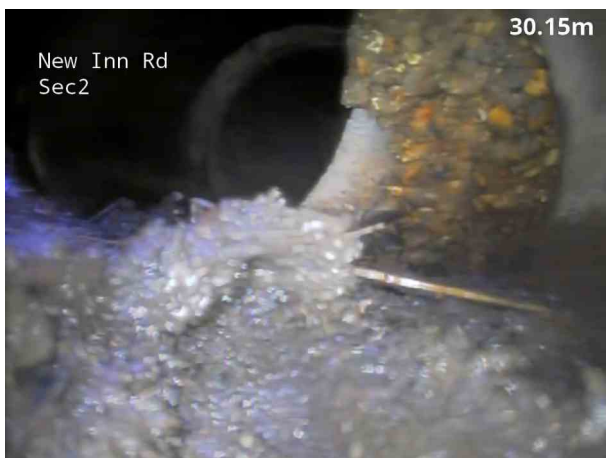
| Scale: 1:211 | Position [m] | Code | Observation | MPEG | Photo | Grade | |
|---|---|---|---|---|---|---|---|
| | 30.40 | SA | Survey abandoned: Unable to continue | 00:04:00 | 21 | | |

21, 00:04:00, 30.40 m  
Survey abandoned, Unable to continue
